METALS HANDBOOK

VOL. 9
FRACTOGRAPHY AND ATLAS OF FRACTOGRAPHY

8th EDITION

Fractography and Atlas of Fractographs

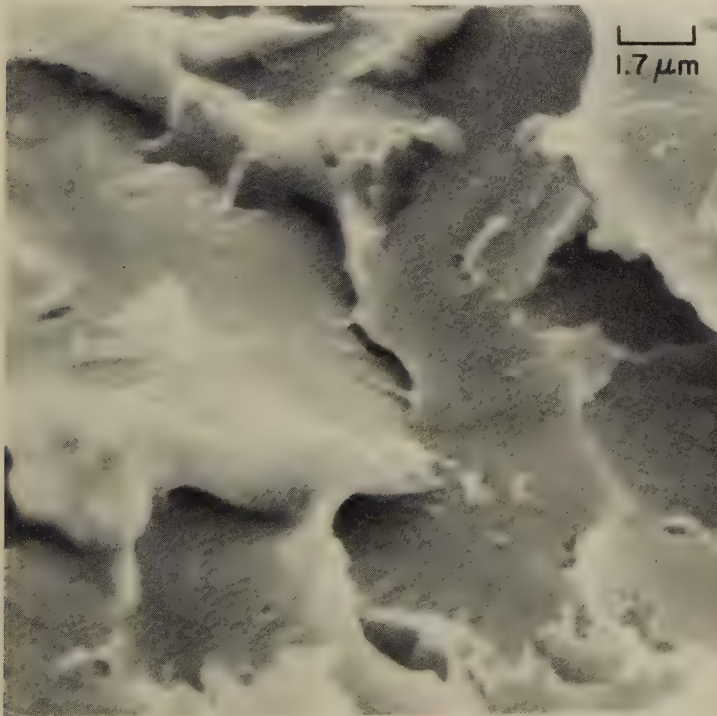
3771 Surface of a Charpy impact fracture produced at -120 C (-184 F) in a specimen of the same steel as in 3770, tempered to the same hardness (260 Bhn), but not given the embrittling treatment, showing facets of transgranular quasicleavage separated by very pronounced, irregular steps. Feathery appearance of river patterns is probably due to poor contrast. See also 3772.

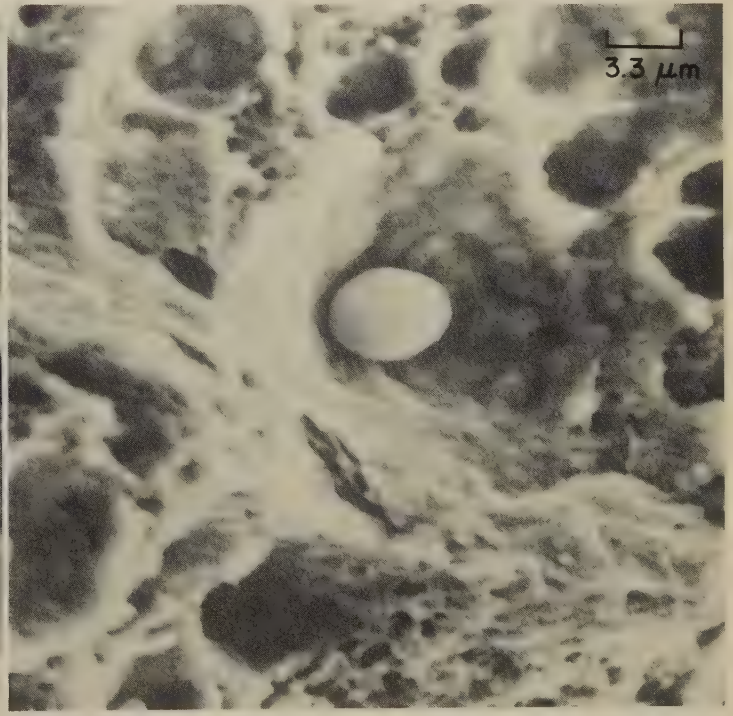
3772 Surface of a Charpy impact fracture produced at 100 C (212 F) in a specimen of the same steel and hardness as in 3770 and 3771, but also without the embrittling treatment described in 3770. Fracture here was by microvoid coalescence; a very wide range of dimple sizes is evident. Inclusions can be seen within dimples; note the large, egg-shaped inclusion at center.

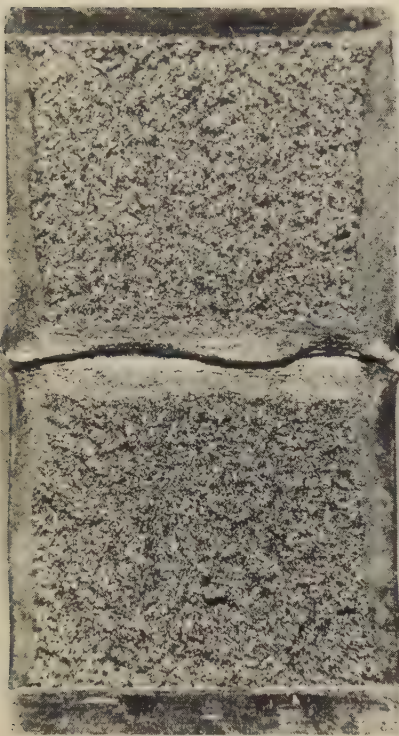
Light fractograph 4.8×
3773 Both fracture surfaces of a specimen that was not aged after austenitizing. See also 3774.

These facing pages present six related pairs of light and SEM fractographs of specimens of an Fe-12Ni-0.5Ti alloy intended for use at cryogenic temperatures. The series shows the effect on Charpy impact energy at -196°C (-321°F), and on fracture-surface characteristics, of the temperature of aging after austenitizing at 900°C (1652°F) for 2 hr and air cooling.

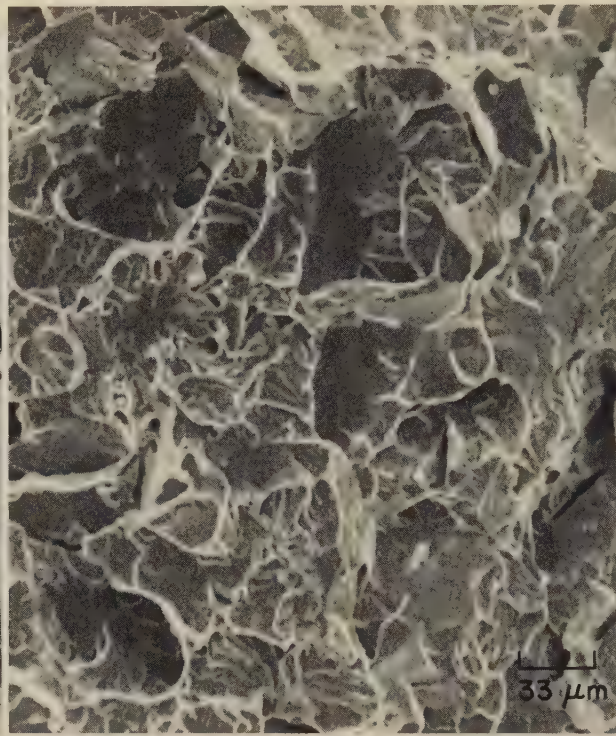
SEM fractograph 300×
3774 This SEM fractograph of the unaged specimen in 3773 shows quasicleavage facets. The impact energy was less than 20 ft-lb.

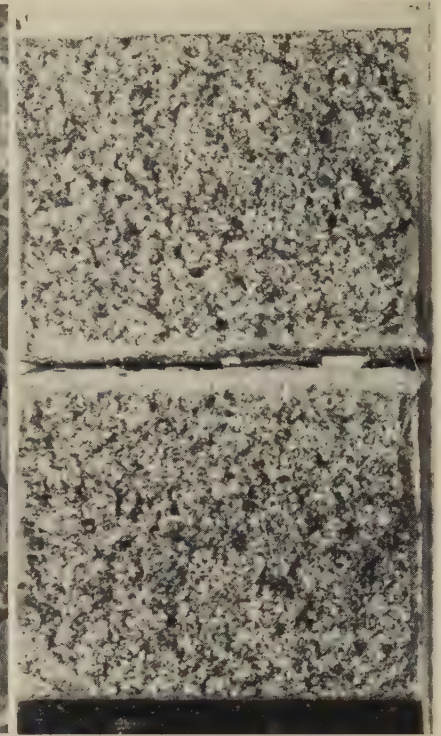
Light fractograph 4.8×
3775 Both fracture surfaces of a specimen aged at 650°C (1202°F) 2 hr and air cooled. See also 3776.

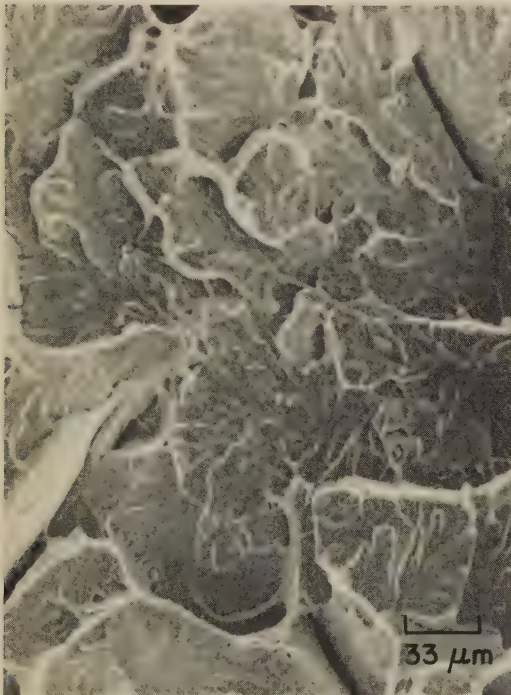
SEM fractograph 300×
3776 This SEM view of the specimen in 3775 shows that aging at 650°C (1202°F) produced almost no change in fracture-surface characteristics from those of unaged specimen in 3774. Impact energy was less than 20 ft-lb.

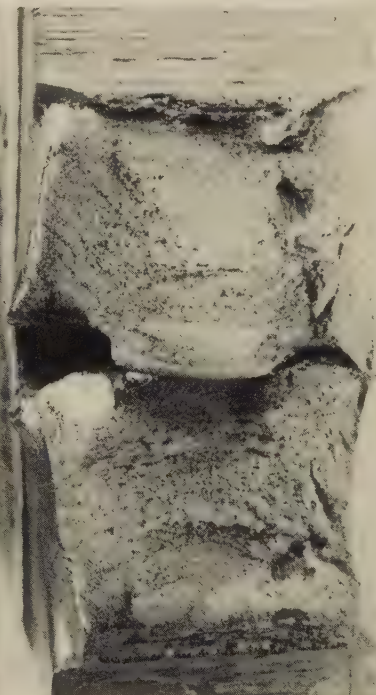
Light fractograph 4.8×
3777 Both fracture surfaces of a specimen aged at 700°C (1292°F) 2 hr and air cooled. Impact energy was about 150 ft-lb. Much deformation accompanied fracture. See 3778.

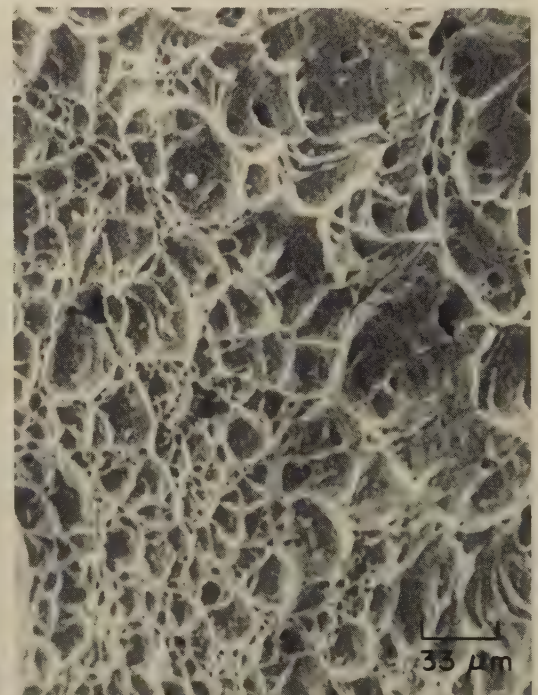
SEM fractograph 300×
3778 This SEM fractograph of the specimen in 3777, which was aged at 700°C (1292°F), shows dimpled rupture instead of the quasicleavage facets observed in the specimens in fractographs 3774 and 3776.

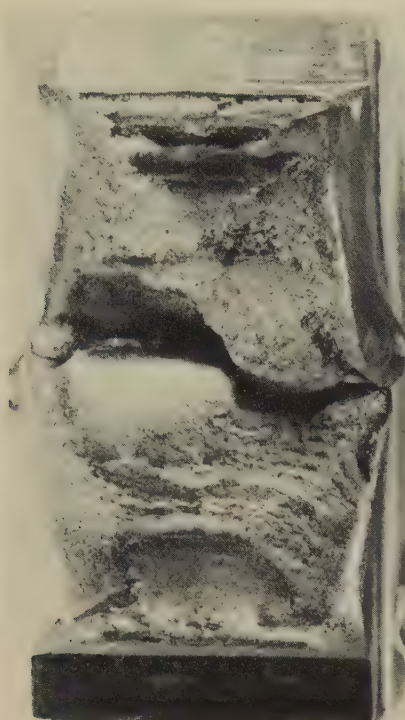
Light fractograph 4.8×
3779 Both fracture surfaces of a specimen aged at 750°C (1382°F) 2 hr and air cooled. Impact energy was about 150 ft-lb; deformation is similar to that in 3777. See 3780.

These facing pages present six related pairs of light and SEM fractographs of specimens of an Fe-12Ni-0.5Ti alloy intended for use at cryogenic temperatures. The series shows the effect on Charpy impact energy at -196°C (-321°F), and on fracture-surface characteristics, of the temperature of aging after austenitizing at 900°C (1652°F) for 2 hr and air cooling.

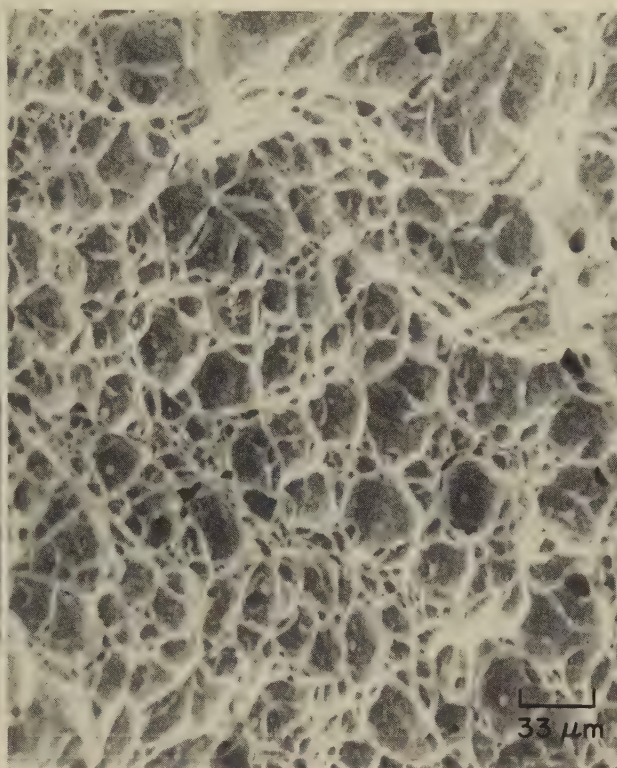
SEM fractograph 300×
3780 Scanning electron microscope fractograph of the specimen in 3779. This fracture, like that of the specimen in 3778, shows dimpled rupture. 33 μm

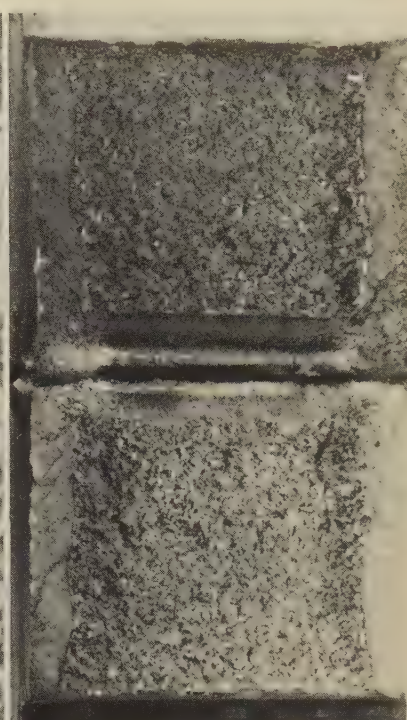
Light fractograph 4.8×
3781 Specimen aged at 800°C (1472°F) 2 hr and air cooled. Unlike 3779, this fracture shows little deformation, and impact energy was less than 20 ft-lb. See also 3782.

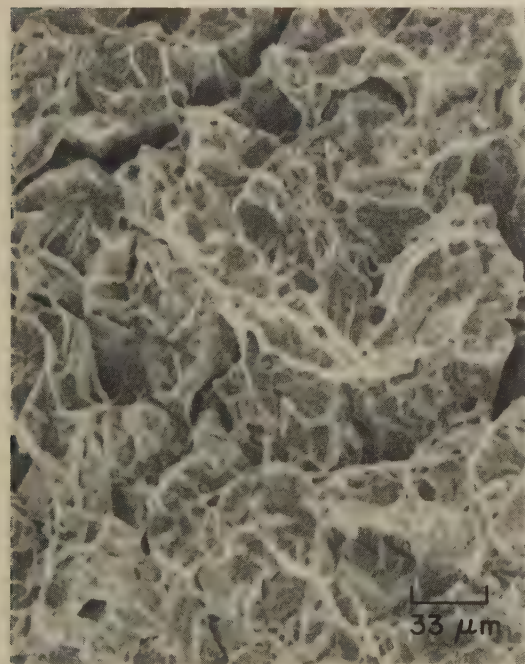
SEM fractograph 300×
3782 SEM view of specimen in 3781. Fracture appears to have propagated by a mixture of intergranular separation and cleavage, yet shows indications of some dimples. Note the deep secondary intergranular cracks. 33 μm

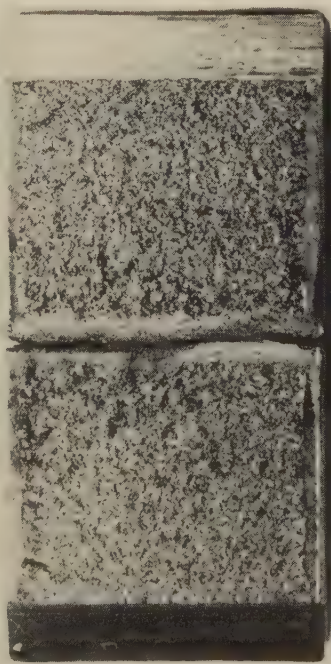
Light fractograph 4.8×
3783 Specimen aged at 850°C (1562°F) 2 hr and air cooled. The fracture is much coarser than that of the specimen in 3781, but is similar to it in other respects. See 3784.

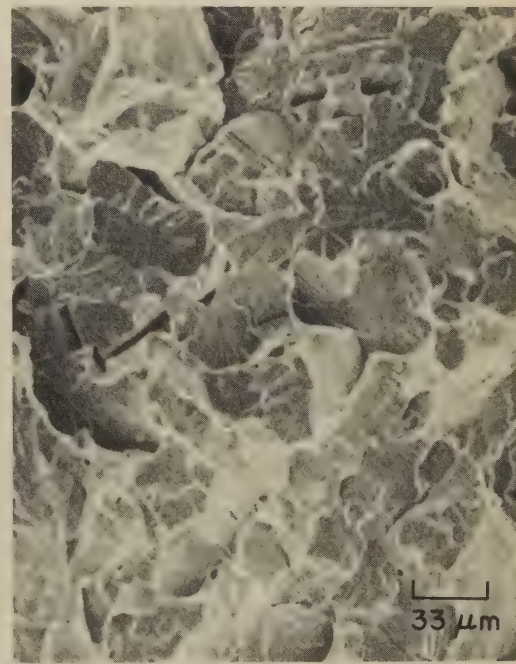
SEM fractograph 300×
3784 This SEM fractograph of the specimen in 3783 shows that the fracture, like that in 3782, exhibits cleavage facets and short, deep intergranular cracks. This specimen also had impact energy of less than 20 ft-lb. 33 μm

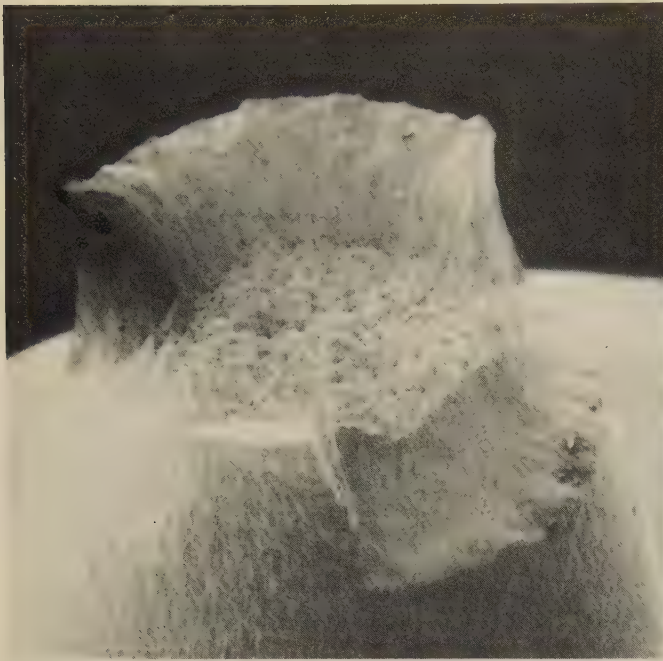
3785 Surface of a fracture in a tensile-test specimen of 18% Ni, grade 300, maraging steel aged 3 hr at 482 C (900 F), broken at room temperature. The crack-initiation zone (at center) is an example of extremely uneven fibrous fracture; there appear to be no radial marks leading to the base of the surrounding shear lip. The shear lip is of the pronounced type that is observed when a large reduction in cross-sectional area accompanies fracture. See also 3786 to 3789.

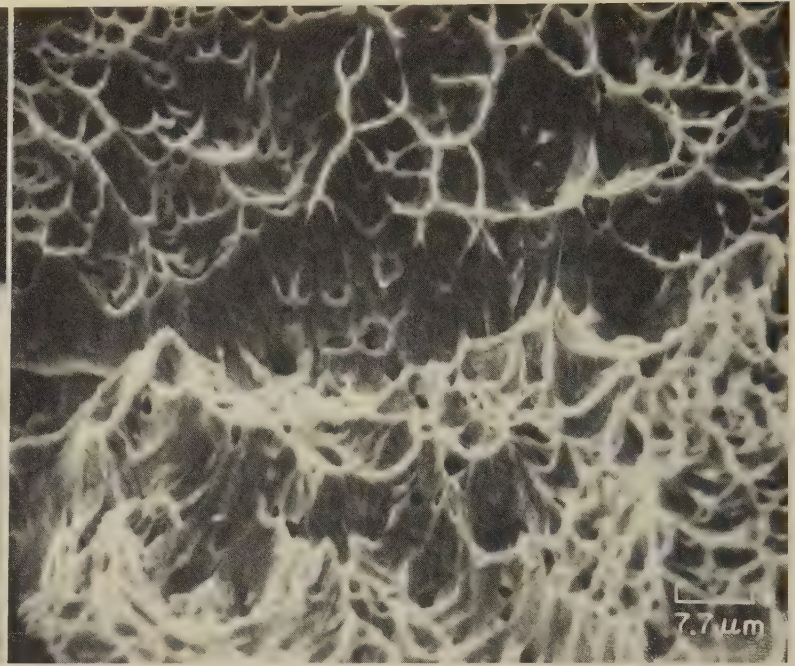
3786 SEM view of the fracture surface of the specimen of 18% Ni, grade 300, maraging steel in fractograph 3785 (left), showing a region in the area of transition from fibrous fracture in the central zone to fracture by shear in the surrounding lip. Visible in the lower portion of the fractograph are the equiaxed dimples (viewed obliquely) that are characteristic of fracture in pure tension; above are the elongated dimples of the shear lip. Note the horizontal boundary between these two types of fracture. See also fractographs 3787 and 3788, below.

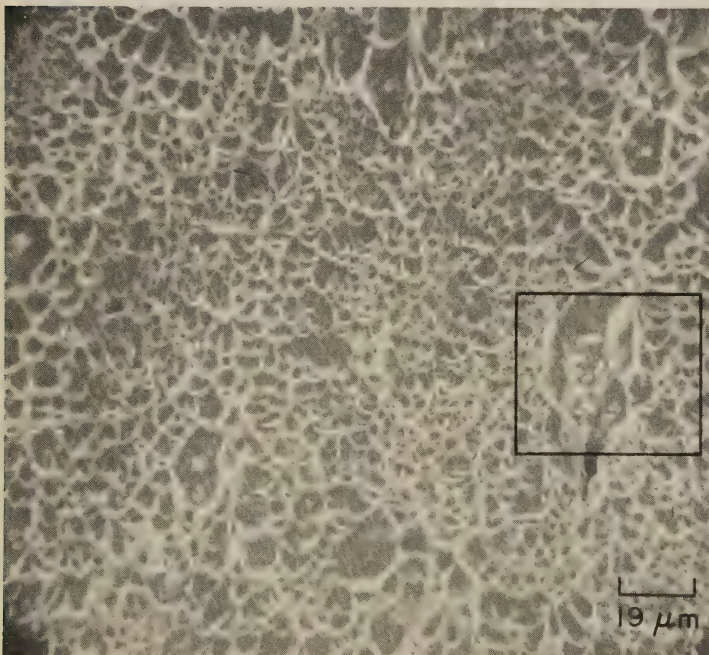
3787 View of the shear-lip region of the fracture surface in 3785 (above). Microvoid coalescence here has produced shear dimples with characteristic elongated shape. Note the large voids, which formed at inclusions of Ti(C,N). The matrix did not adhere to these inclusions, which allowed the voids to open early in the fracture process and to grow large. See 3788 (right) for a higher-magnification view of the area within the rectangle.

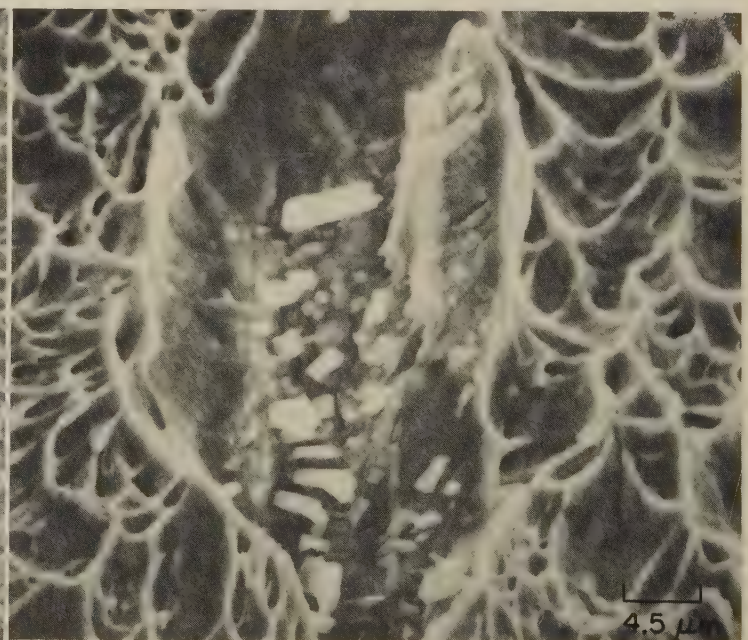
3788 Higher-magnification view of the area in the rectangle in 3787, showing one of the very large voids. Clearly visible is the array of Ti(C,N) inclusions that triggered the formation of this void. These may have been separate particles originally, or they may be segments of one or more larger particles that broke apart before the void opened. Except for a few tiny dimples visible here (lower right), the region in 3787 was found to lack the dispersion of fine dimples normally present in surfaces of tensile-test fractures.

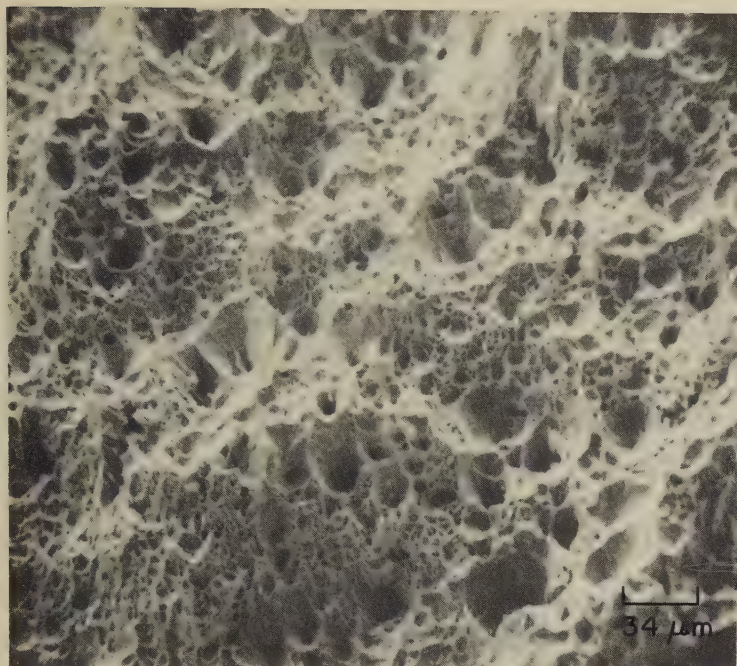
3789 Another view of the surface of the tensile-test fracture in 18% Ni, grade 300, maraging steel in 3785 (facing page), showing a portion of the central zone of the fracture, close to the origin. The surface here is composed of equiaxed dimples of two different sizes. The larger dimples probably formed at Ti(C,N) particles; all of the dimples were caused by particles of some sort.

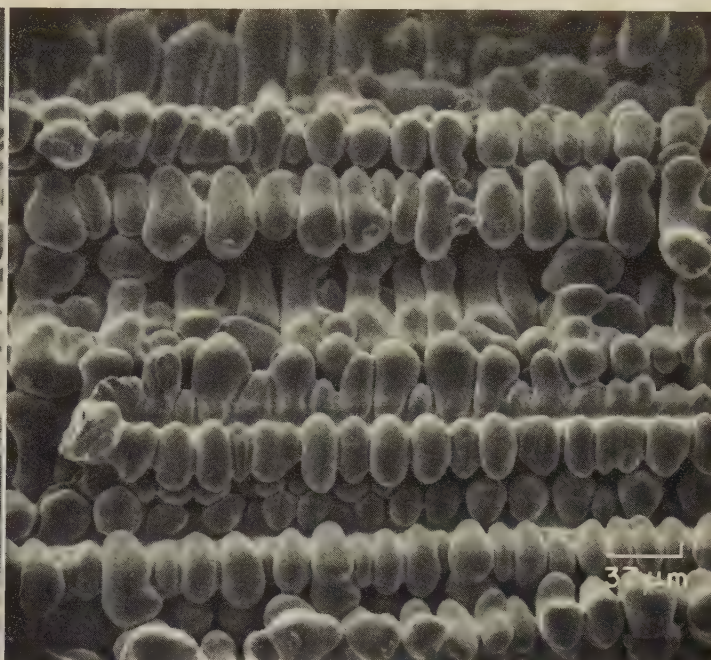
3790 Surface of a tensile-test fracture in a cast specimen of 18% Ni, grade 300, maraging steel, showing a region where the fracture intersected a shrinkage cavity and exposed dendrites whose growth during solidification was arrested by a lack of molten metal within the cavity. In this view, the primary dendrite arms are oriented horizontally. See also 3791 and 3792.

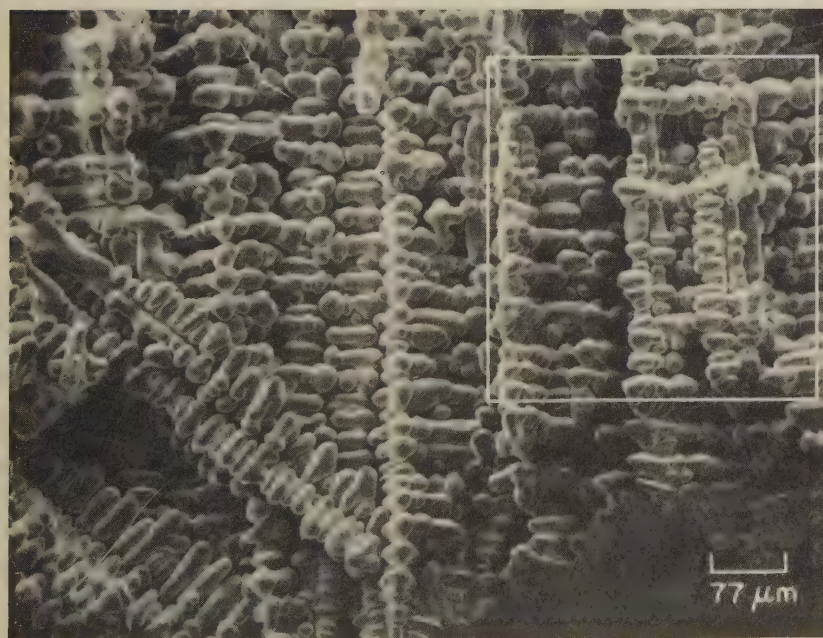
3791 Lower-magnification view of the exposed dendrites in the shrinkage cavity in the cast specimen of 18% Ni, grade 300, maraging steel in 3790, showing dendrites that formed at different orientations. Had this casting been properly risered, the channels between the dendrite arms would have been filled, forming continuous metal. See 3792, which shows the area in the rectangle at higher magnification.

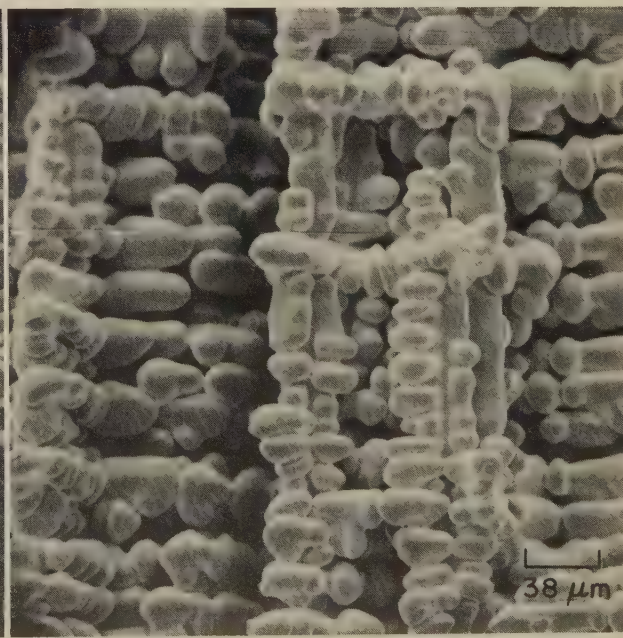
3792 Enlarged view of the area outlined by the rectangle in fractograph 3791. Primary dendrite arms are oriented vertically here; secondary arms are at various orientations normal to the primary arms. Appreciable secondary-arm growth is evident, but the higher-order branching often found in castings has not occurred.

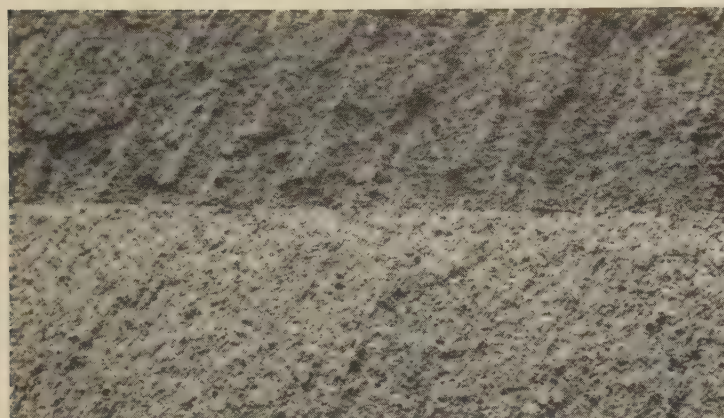
SEM fractograph 26×
3793 Fracture surface of a fracture-toughness specimen of 18% Ni, grade 300, maraging steel; the heat treatment of this specimen was not reported. This view shows entry of the fatigue crack from bottom, and sharp onset of final, fast fracture at center. See also fractographs 3794 and 3795; compare with 3796.

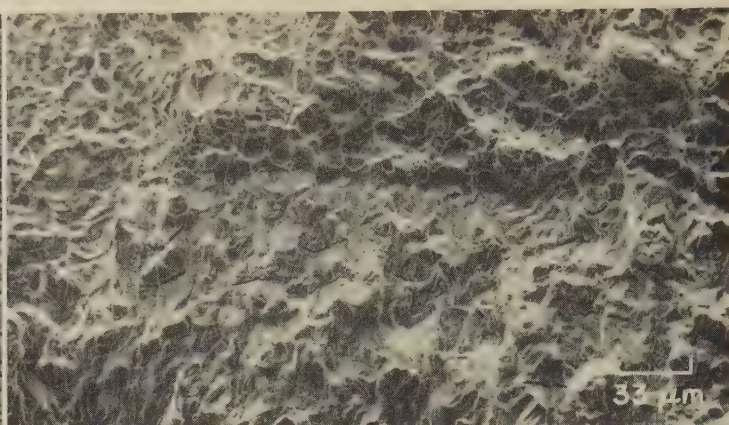
SEM fractograph 300×
3794 A view, at higher magnification, of the fracture surface shown in 3793, with the fatigue-crack surface at bottom and the fast-fracture surface at top. Note the secondary cracks, and lack of clear fatigue striations, in the fatigue area. See also fractograph 3795 (below, at left).

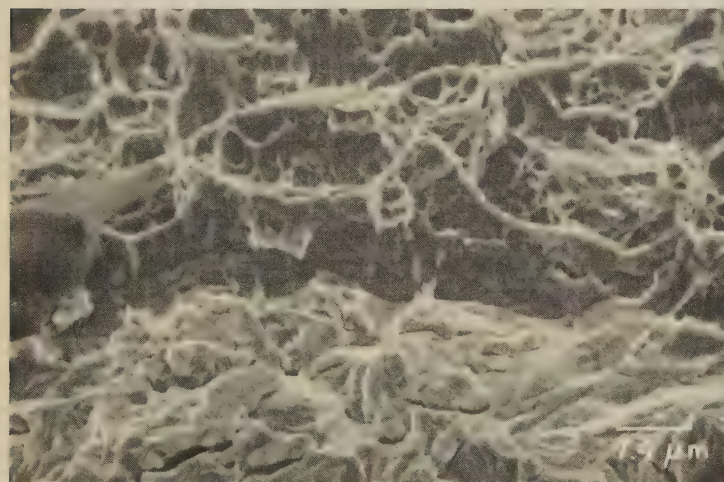
SEM fractograph 1350×
3795 Same fracture surface in 18% Ni, grade 300, maraging steel as in fractographs 3793 and 3794 (above), shown here at still higher magnification. At bottom, fatigue has produced numerous secondary cracks. Note the stretched zone at center, at the transition from fatigue to final, fast fracture.

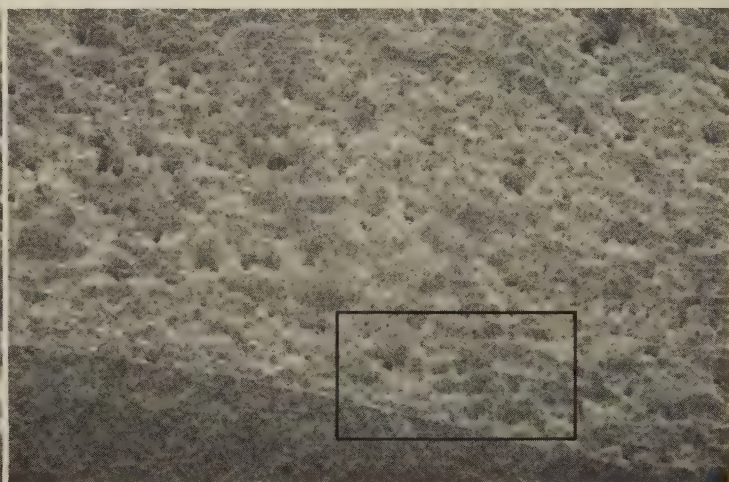
SEM fractograph 47×
3796 Fracture surface of a fracture-toughness specimen of 18% Ni, grade 300, maraging steel aged 3 hr at 538 C (1000 F) and air cooled. Fatigue crack at bottom; ductile, tension-overload fracture at top. Note ridges, spaced at about 60 microns, in ductile region parallel to crack front. See 3793, 3797 and 3798.

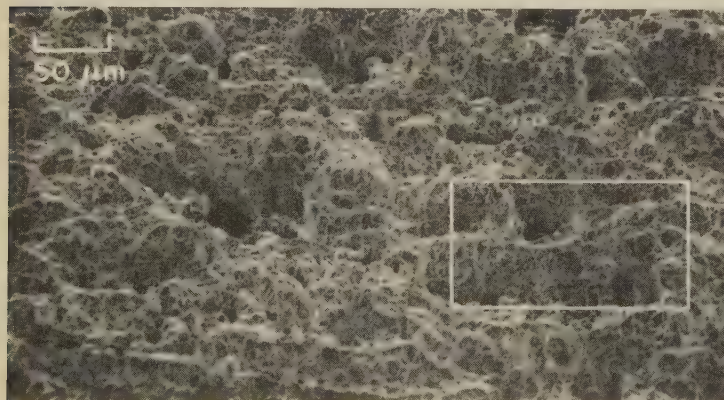
SEM fractograph 200×
3797 Higher-magnification view of the area in the rectangle in 3796. Tension-overload dimples are clearly shown, but no details of the fatigue zone (bottom) are visible. The discontinuous nature of the ridges in the tension-overload region is evident. See 3798 for enlarged, composite view of area in rectangle here.

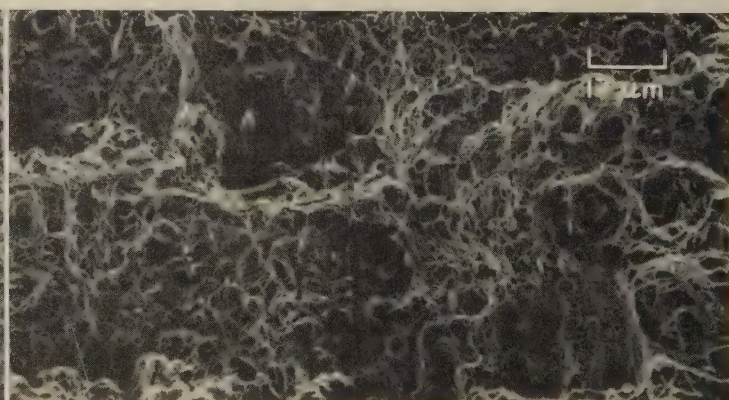
SEM fractograph 600×
3798 This is a composite of four scanning-electron-microscope fractographs of the plane-strain region of the area of tension-overload fracture in the specimen shown in 3796 and 3797, taken from the area within the rectangle in 3797. This shows more clearly the changes in surface orientation between the ridges.

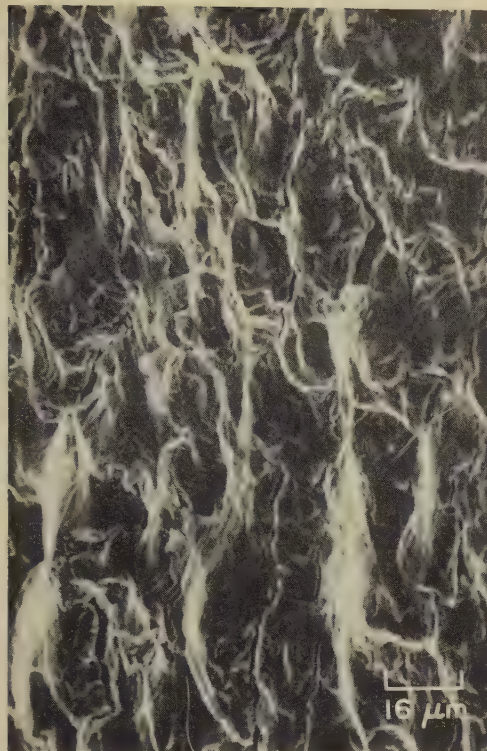
SEM fractograph 640×
3799 A low-cycle fatigue fracture (at about 3000 cycles) of 18% Ni, grade 300, maraging steel that had been annealed 1 hr at 816 C (1500 F) and air cooled. There is no evidence of clearly defined striations, but there is a system of more or less parallel secondary cracks. See also 3800, 3801.

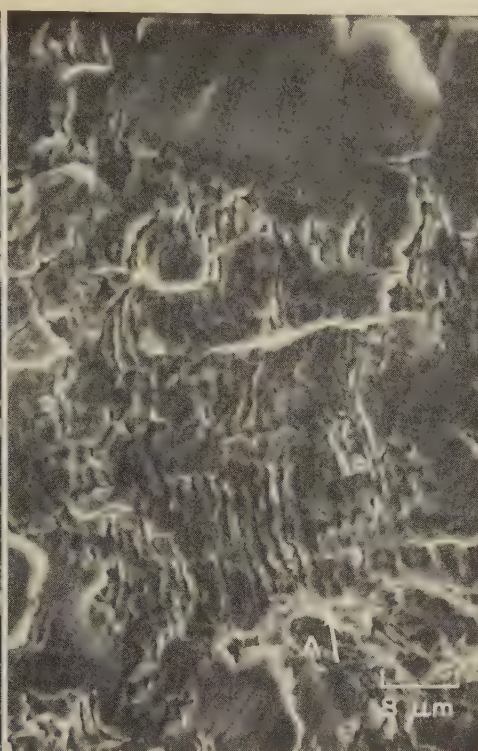
SEM fractograph 1250×
3800 A view of a different area of the fracture in fractograph 3799 (at left). Note that in this area quite regular striations are in evidence, many of them with fissures at their roots (as at A). Note also the several rubbed areas, particularly those at the top. See also 3801, at right.

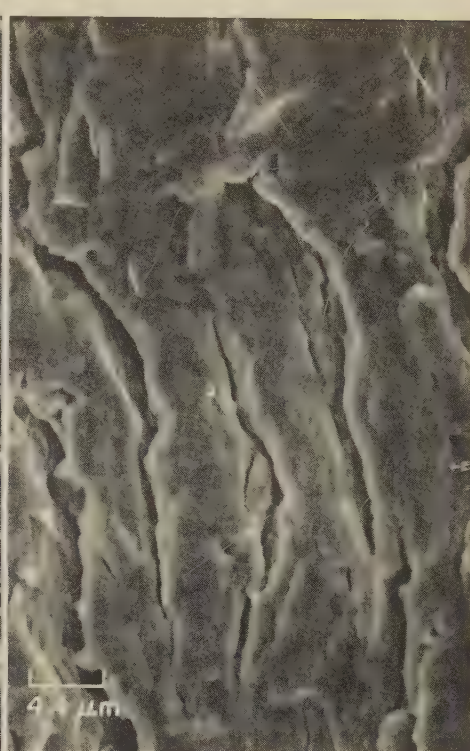
SEM fractograph 2250×
3801 Same fracture as shown in 3799 and 3800, but an area at still another location, as seen at higher magnification. Here again is a system of repetitive fissures that appear to be quite deep and very irregular. There is little evidence of the conventional type of striations in this area.

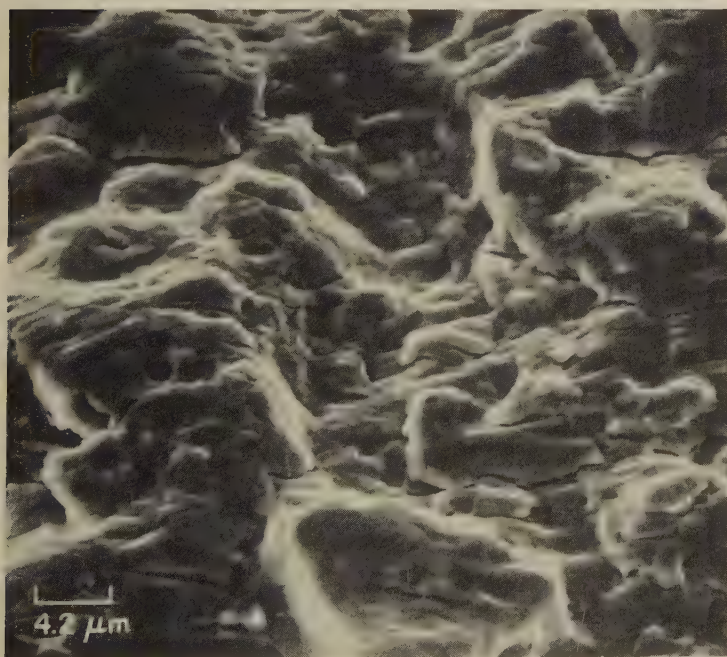
SEM fractograph 2400×
3802 Surface of a low-cycle fatigue fracture (at about 1000 cycles) in 18% Ni, grade 300, maraging steel that had been aged at 482 C (900 F) for 3 hr and air cooled. This fracture surface displays a progression of rather fine but extremely irregular striations, separated here and there by secondary cracks.

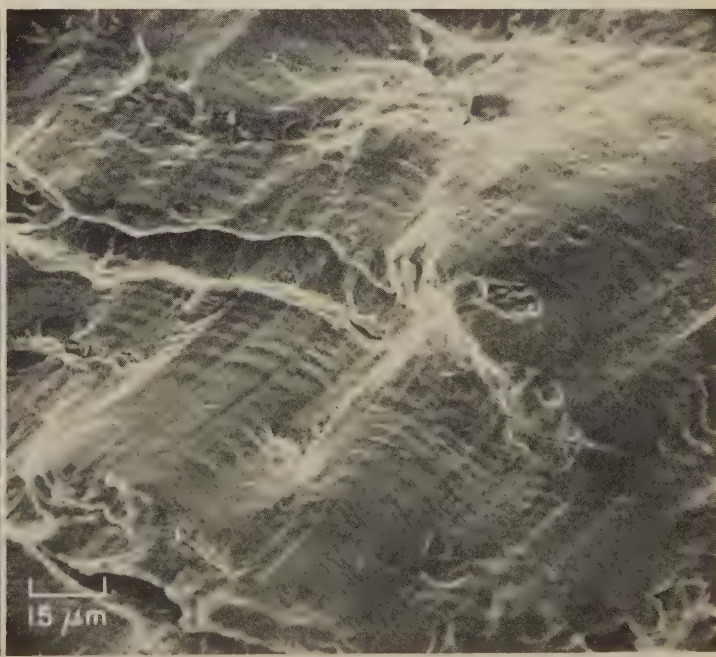
SEM fractograph 670×
3803 Low-cycle fatigue fracture of 18% Ni, grade 300, maraging steel (heat treatment not reported). This has relatively uniformly spaced fatigue striations with fewer secondary cracks than are seen in 3799 to 3802. The pattern of striations is similar to that produced by varied loading in service.

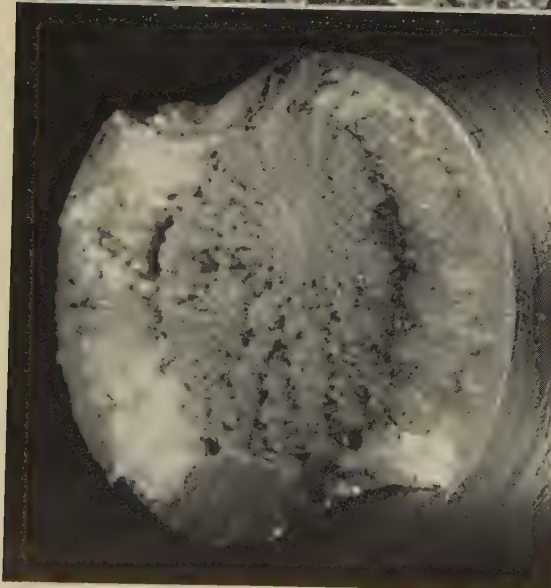
3804 Tension-overload fracture in an unnotched specimen of H11 tool steel heat treated to a tensile strength of 2041 MPa (296 ksi) and 48% reduction in area. Note radial features between fibrous origin (just right of center) and shear lip. See fractographs 3805 and 3806, at right.

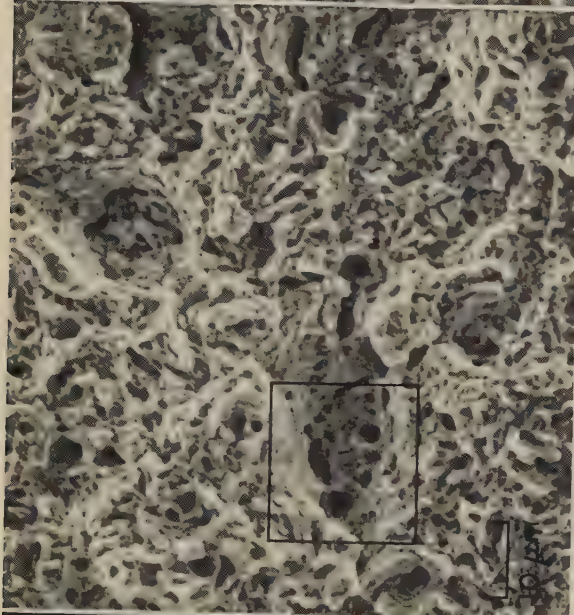
3805 Another view of the fracture surface in 3804, taken in the vicinity of the fracture origin, showing an unusually uneven array of dimpled facets with a scattering of large voids. See 3806 for a higher-magnification view of the area in the rectangle.

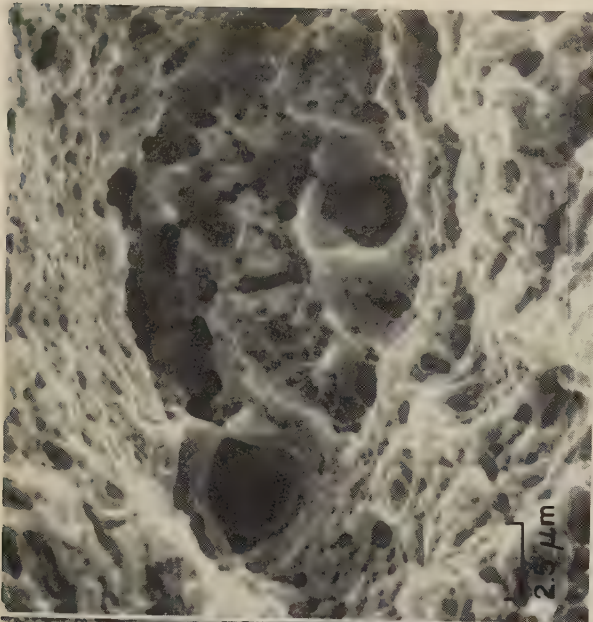
3806 Higher-magnification view of the area in the rectangle in 3805 (left), showing one of the large voids, and clearly revealing dimples of various sizes both at the bottom and along the side walls of the void.

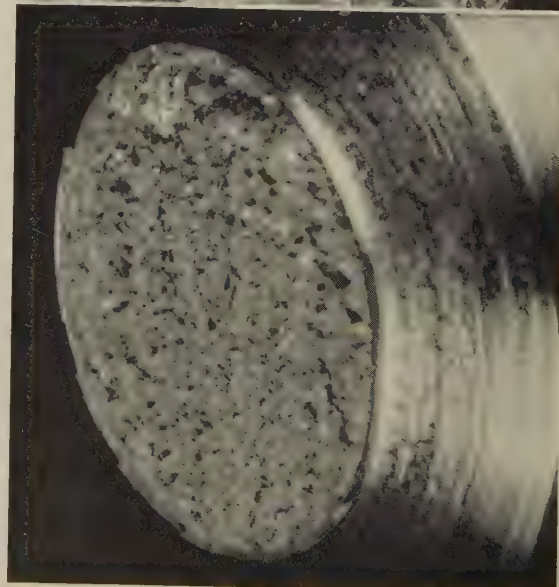
3807 Tension-overload fracture in notched specimen of H11 tool steel (same heat treatment as in 3804). Notched tensile strength ($K_C = 3.5$) is 2665 MPa (386.5 ksi). A flat surface, partly bounded by a hairline shear lip. See also 3808 to 3810.

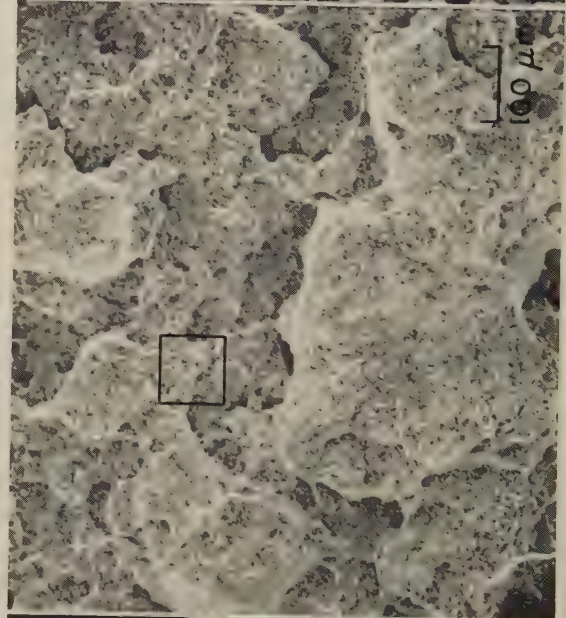
3808 SEM view of the fracture surface in 3807 (left). This surface seems to be generally dimpled, but at this relatively low magnification the features that appear to be dimples are not adequately resolved. See 3809, an enlarged view of area in rectangle.

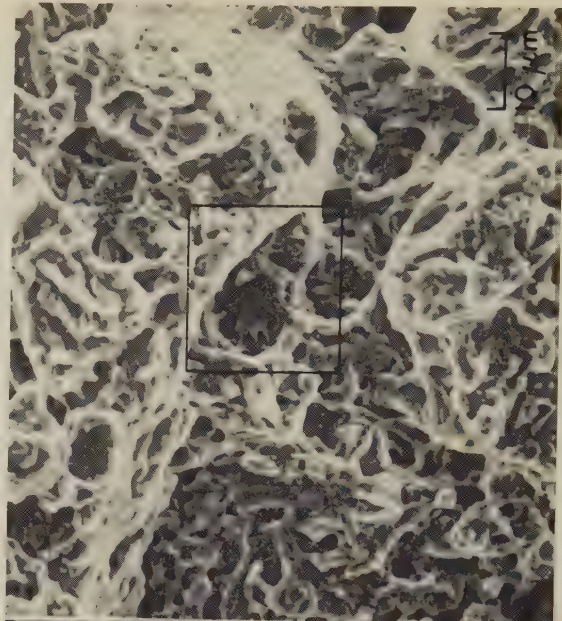
3809 Higher-magnification view of area in rectangle in 3808 (left), showing dimples that are associated with local quasicleavage. Very little evidence of secondary cracking is present. Area in rectangle is shown at higher magnification in 3810 (next page).

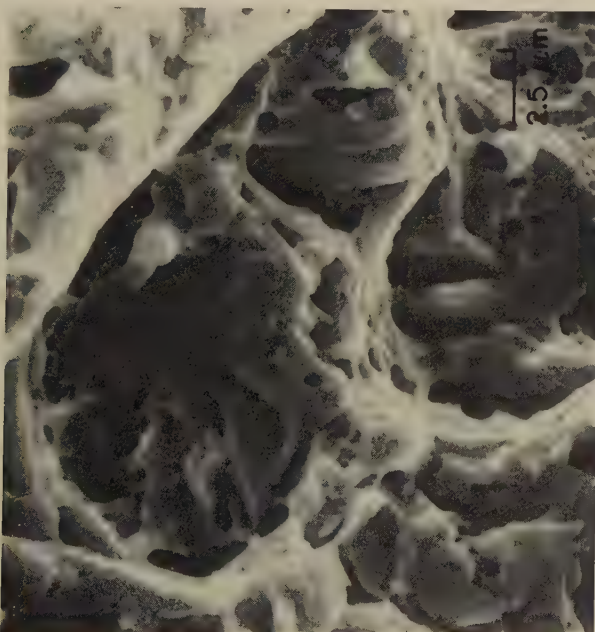
SEM fractograph
3810 Higher-magnification view of the area within the rectangle in fractograph 3809 (facing page). Small quasicleavage facets are visible, both within and adjacent to the larger dimples.

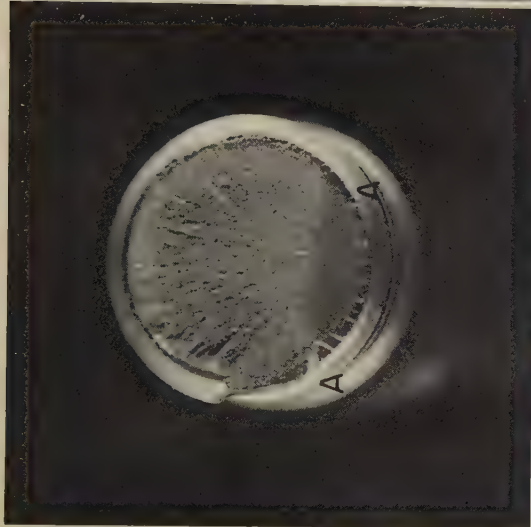
Light fractograph
3811 Low-cycle fatigue fracture in threaded specimen of H11 tool steel (same heat treatment and tensile strength as in 3804) that broke after 21,000 cycles of tension-tension ($R = 0.1$); maximum load, 60% of tensile strength. Dark, crescent-shaped region (A-A) is fatigue portion of fracture. See also 3812 to 3815.

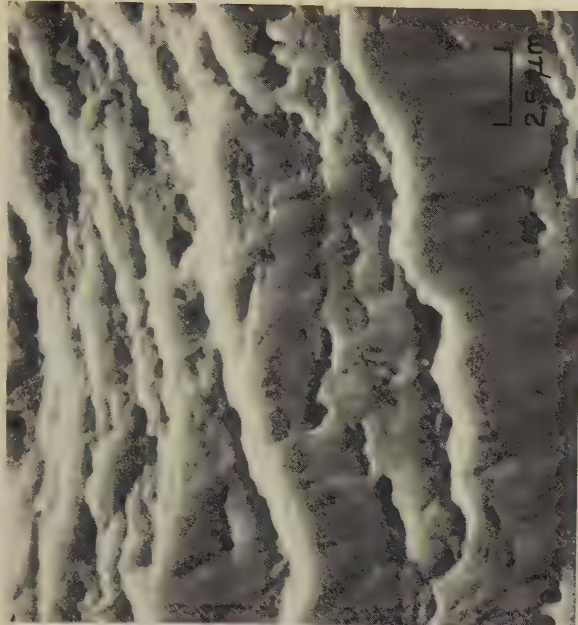
SEM fractograph
3812 SEM view taken near the outer edge of the crescent in 3811. Evident are ridges that are attributed to mechanical damage during shear deformation. In this region, there appear to be no secondary cracks.

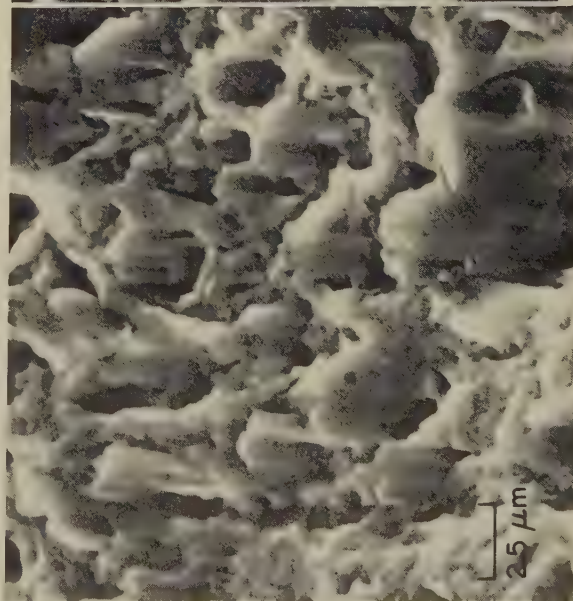
SEM fractograph
3813 View of the crescent in 3811, showing a region farther from the outer edge than 3812 is, and revealing ridges, formed during shear deformation, that have very irregular crests.

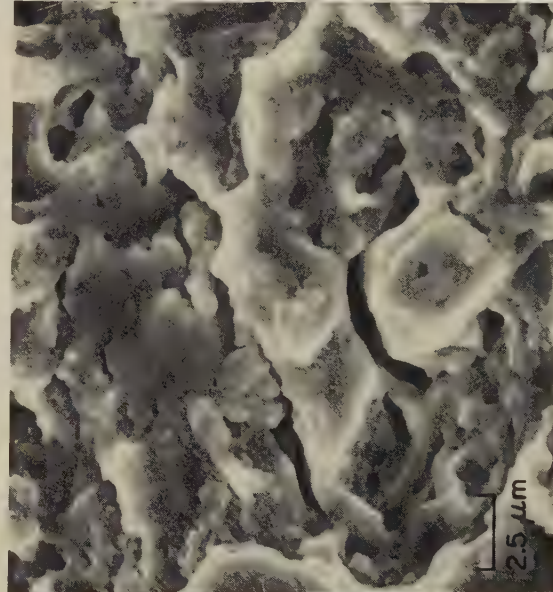
SEM fractograph
3814 Another view of the crescent in 3811, showing a region still farther from the outer edge than 3813 is. This region shows little evidence of conventional fatigue striations but reveals small cleavage facets, many of which are separated by secondary cracks.

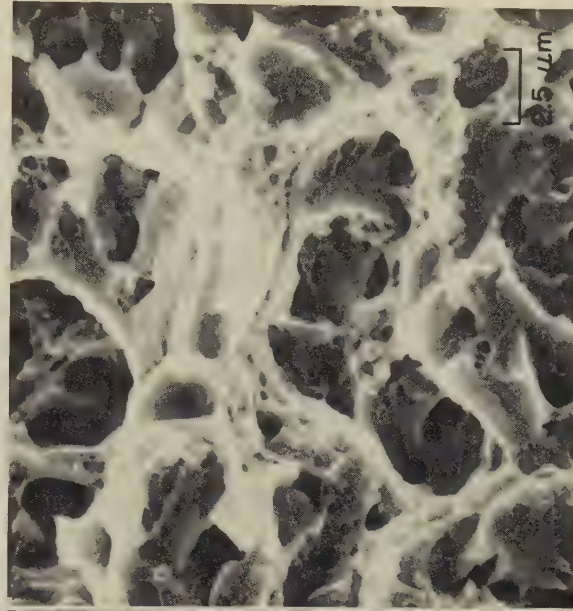
SEM fractograph
3815 View of the fracture surface in 3811, showing a region in the zone of final fast fracture, and revealing the equiaxed dimples expected in a tension-overload fracture. No secondary cracks are visible.

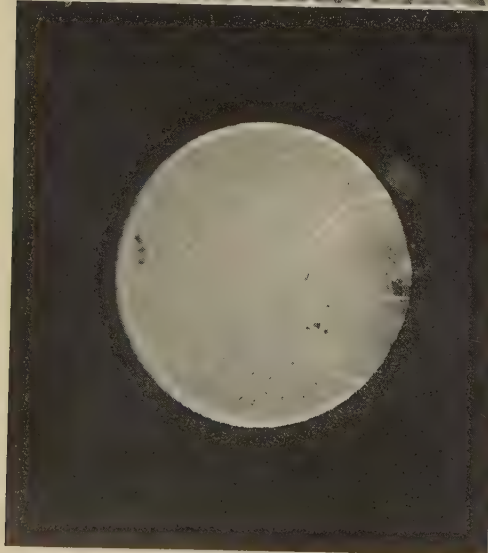
3816 High-cycle fatigue fracture in H11 tool steel heat treated to a tensile strength of 2041 MPa (296 ksi) and 48% reduction in area, which broke after 775,000 cycles of tension-tension ($R = 0.1$) under a maximum load of 30% of tensile strength. The fatigue-crack origin is at the outer edge of the crescent-shaped region at bottom. See also 3817 and 3818.

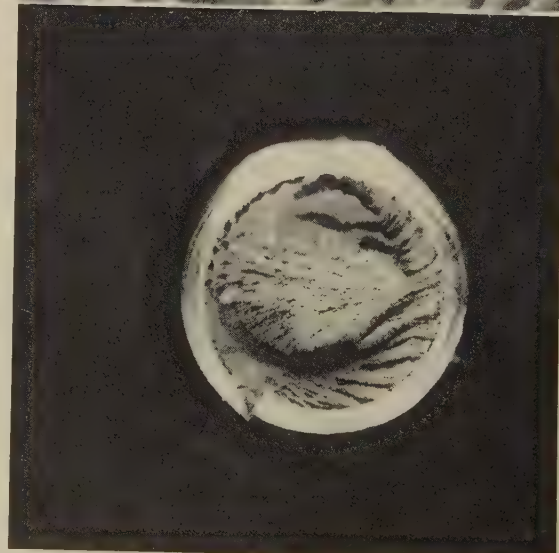
3819 Fracture caused by hydrogen embrittlement in threaded specimen of H11 tool steel (same heat treatment and tensile strength as in 3816). Hydrogen impregnation was by plating. Fracture occurred before the full sustained load could be applied and progressed around the circumference of the specimen. See 3820 to 3823.

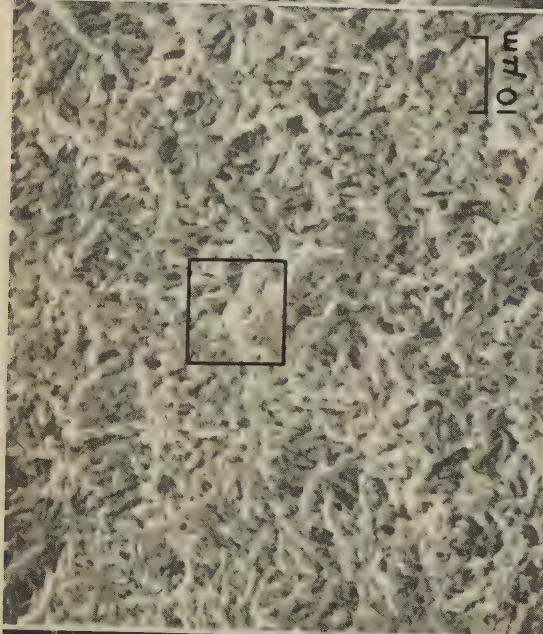
3817 An area within the crescent-shaped (fatigue) region of the fracture surface in 3816. The surface contains many pockmarks, which resemble dimples. There are no suggestions of fatigue striations. See 3818 for an enlargement of area in rectangle.

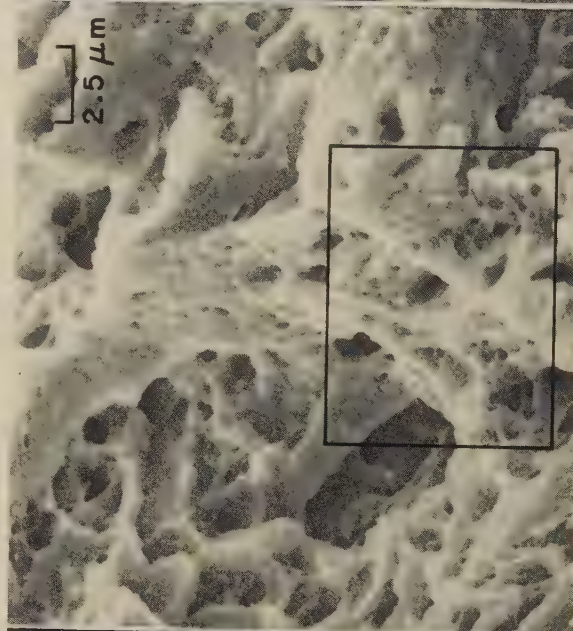
3820 SEM view of the fast-fracture region of the fracture surface in 3819, showing an unusual type of surface for a specimen heavily charged with hydrogen. Fracture occurred mainly by microvoid coalescence; there is no evidence of intergranular rupture. Area in rectangle is shown at higher magnification in 3821.

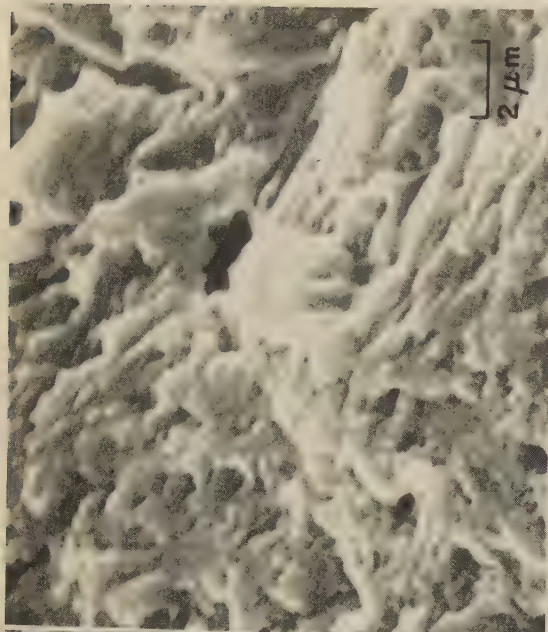
3818 Higher-magnification view of the area within the rectangle in 3817 (left). Some of the contours suggest striations, but they are very localized. Some features resemble cleavage facets but do not have the degree of flatness that is normally expected of cleavage.
